DEVELOPMENT OF BIOTECHNICAL METHODS TO CONTROL SHORELINE EROSION

FINAL REPORT

Dr. D. A. Mays
Dr. K. R. Sistani

December 1, 1999

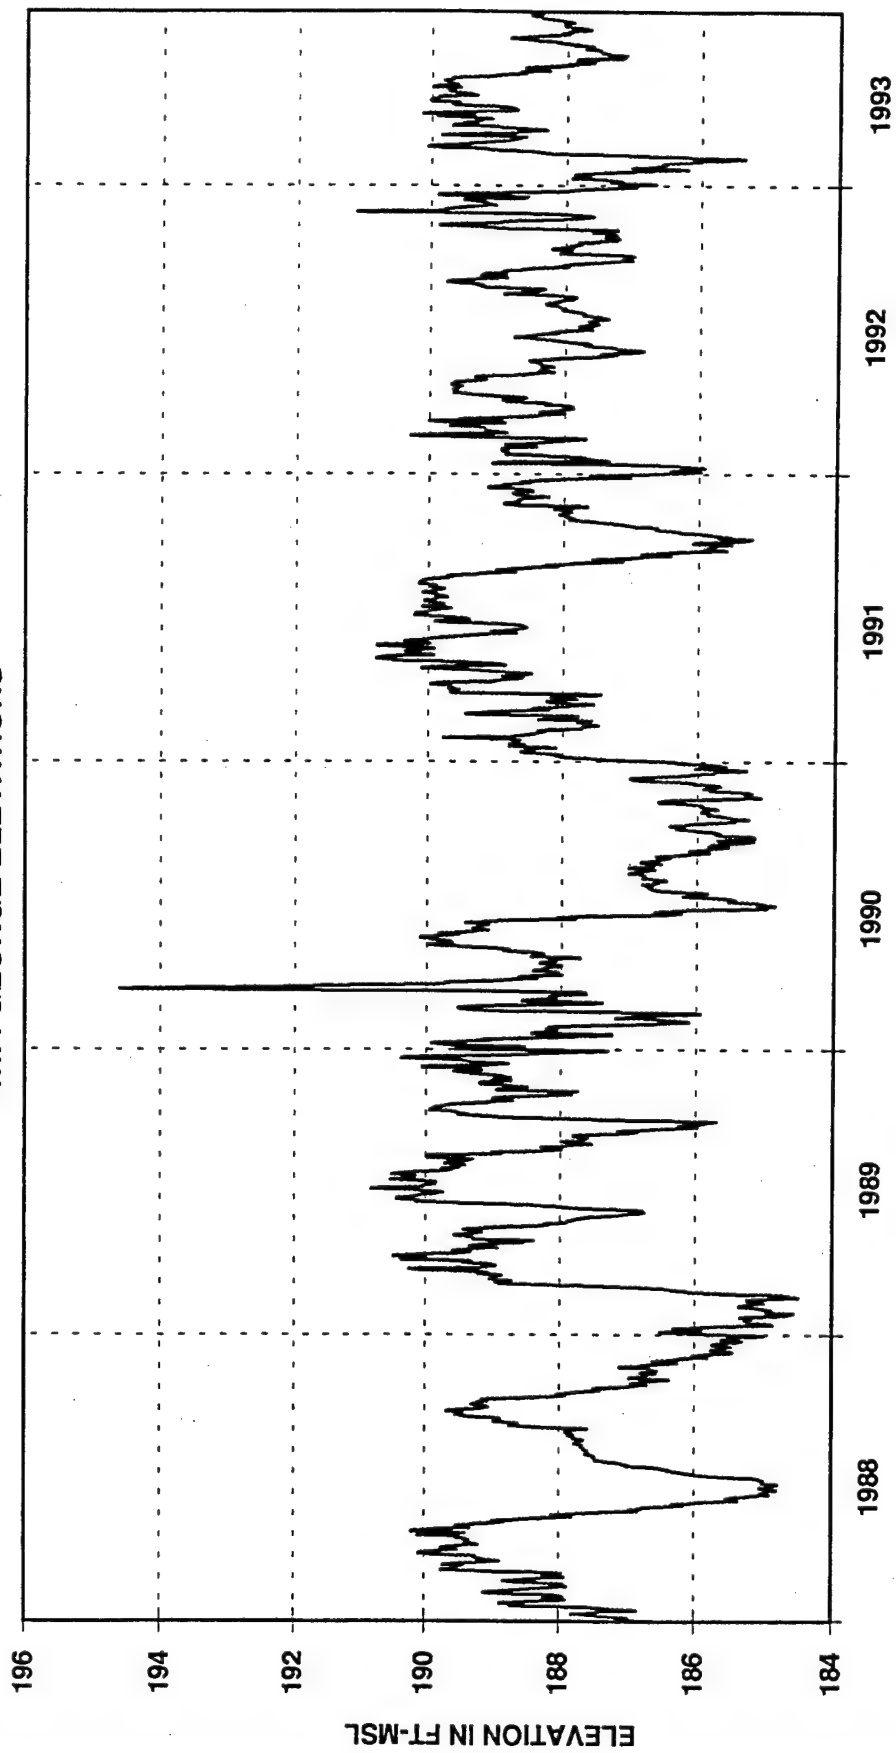
Typical fluctuations in lake elevations

W.F. GEORGE ELEVATIONS

Damage to private property has resulted because insufficient shoreline was purchased by the government before the lake was constructed. The water level in the lake varies from about 184.5 to 190 feet above sea level on a fairly regular basis because of navigation requirements and seasonal conditions. There is a navigation window about once a month at which time water is released from the lake to increase the depth of the Appalachicola River downstream to the minimum depth for barges. This results in a drop of several feet in the lake level. The level is then allowed to rise gradually until the next navigation window. Because of this fluctuation the lake is alternately at full pool with the waves lapping at the shoreline or has a dry beach as much as 40 or 50 feet in width. Almost all the erosion occurs when the lake is a full pool or above and the waves undercut the banks causing the soil to slough off into the water. The most severe wave action is due to winds blowing across the lake, however, boat wakes also cause some problems.

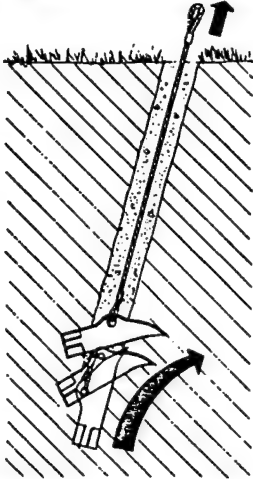
How Duckbill Works

The Duckbill Anchor is driven into the soil using a hammer and drive rod. As the anchor is being driven it is actually compacting the soil around the anchor body. Once the anchor is to the proper depth the drive rod is removed. An upward pull on the cable rotates the anchor into load lock position. The anchor cuts into and further compacts the undisturbed soil. This method is far superior to conventional anchors that disturb the soil during installation.

Undisturbed soil

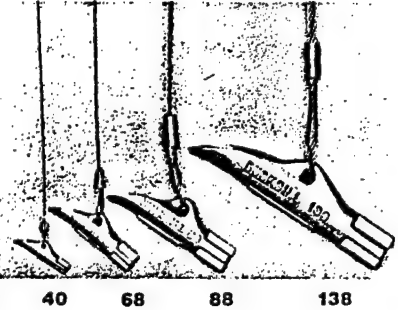
Specifications

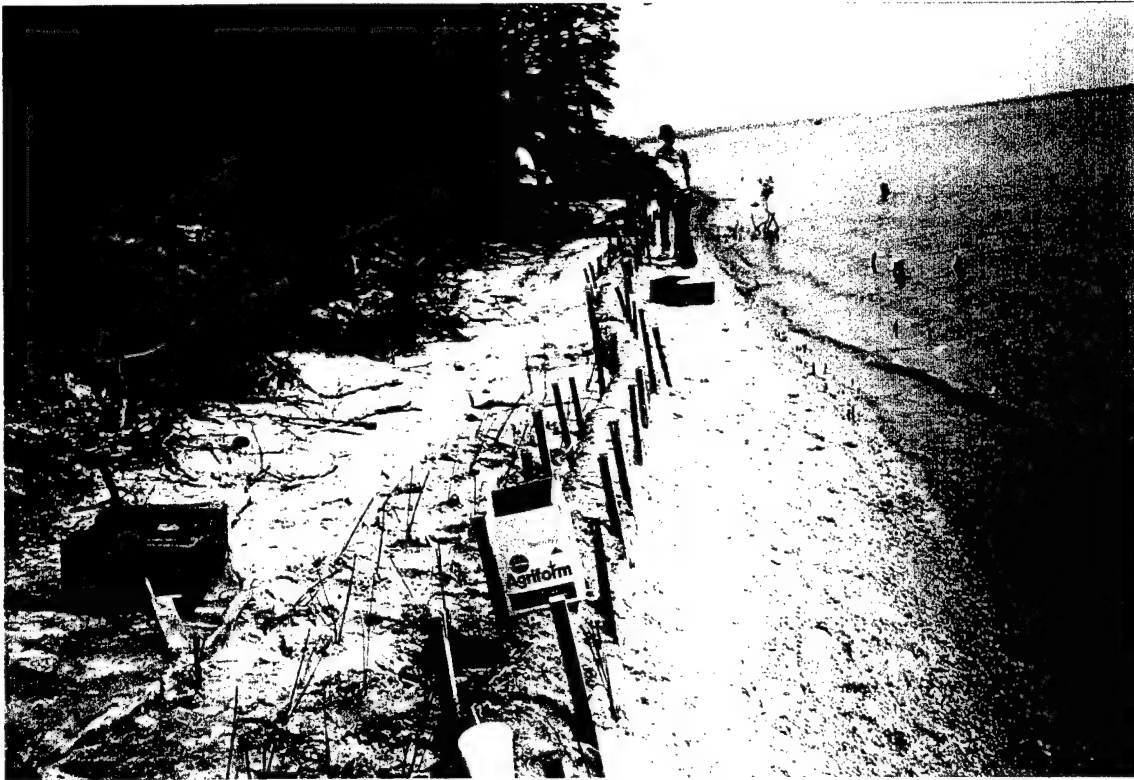
12 inch coconut fiber log breakwater.

Coconut fiber (coir) logs which were 10 feet long and 1 foot in diameter were compared with wheat straw bales (14 inches x 18 inches by 3 feet) wrapped in poultry netting to provide protection from wave action. These breakwater materials were placed at an elevation of 189 feet in sections of 100 feet of each material replicated 3 times. We placed an additional 150 feet of straw bales at one end. Thus, approximately 750 feet of shoreline was treated. Both the coconut fiber logs and straw bales were secured in place with 3-foot wooden stakes placed 2 feet apart on each side then wired together on top of the breakwater material.

The coconut fiber logs cost about \$10 per linear foot delivered at the job site while the straw bales cost less than \$3 per foot including the cost of the poultry netting and the labor for wrapping. The cost of wooden stakes added about \$0.75 per linear foot. Breakwater materials were installed on April 20-23, 1994. The labor cost for installing these materials added an additional \$1.00 to \$1.50 per linear foot of shoreline.

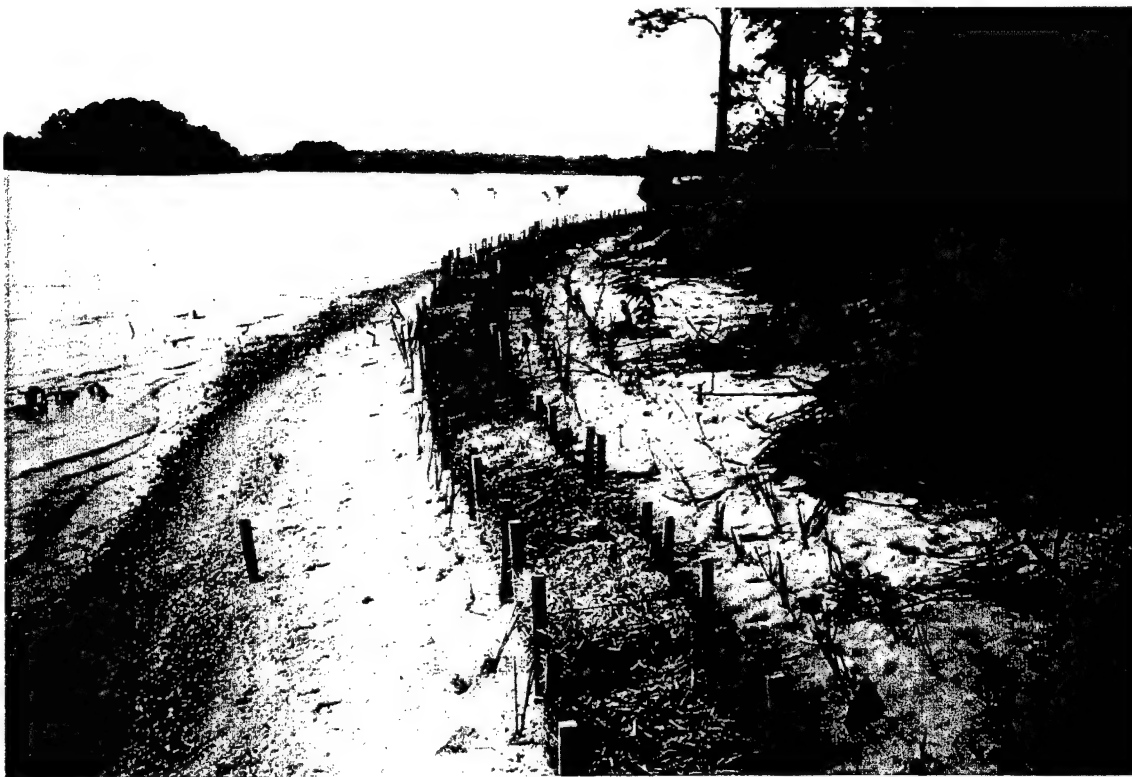
Chicken wire wrapped straw bale breakwater.

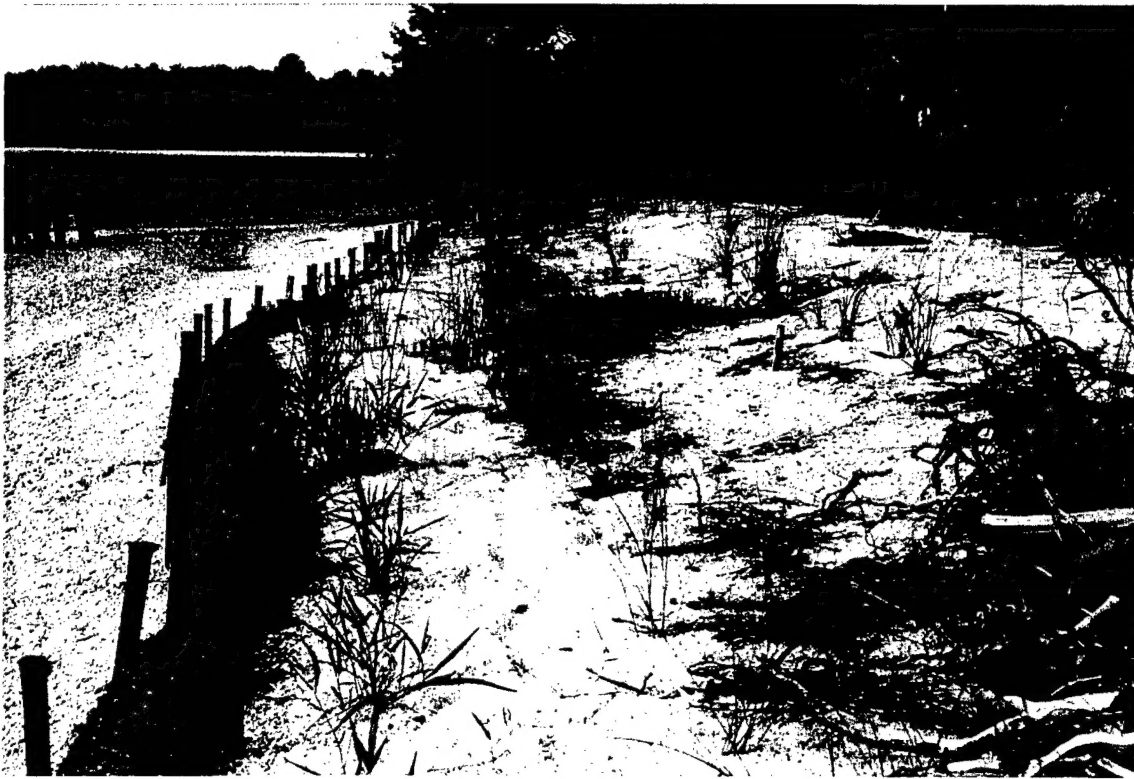
Vegetation growing behind breakwater.

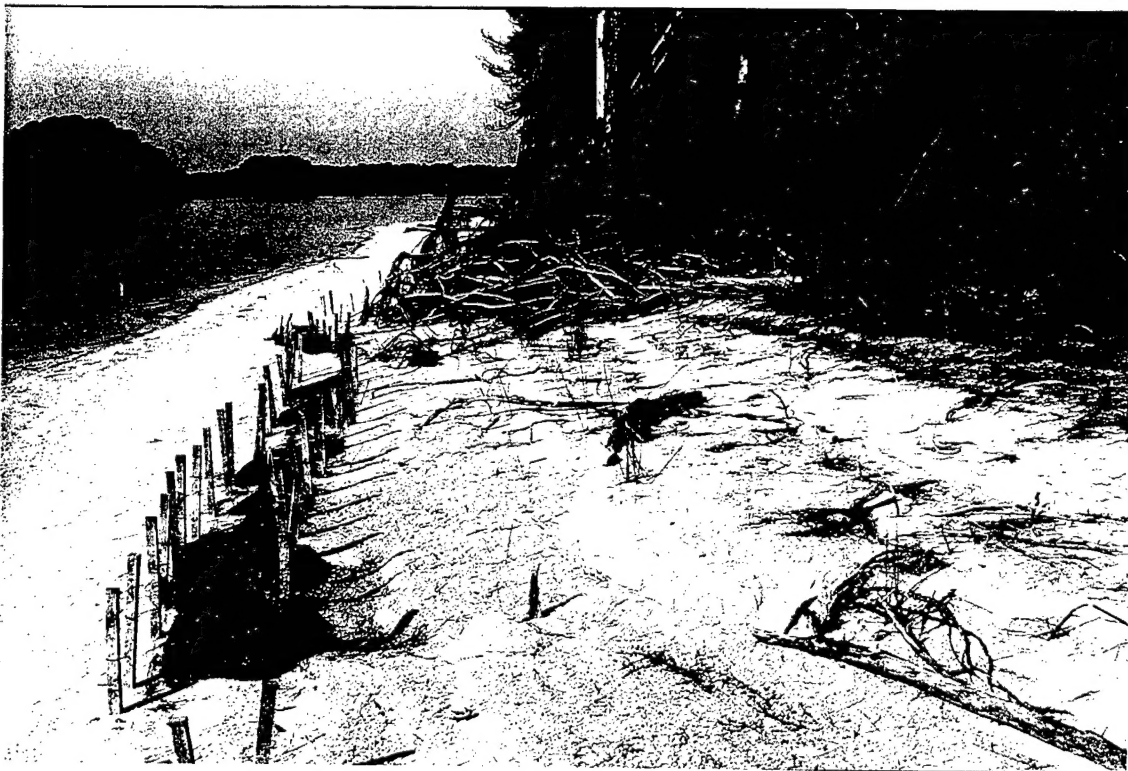
Storm associated with Gulf Coast hurricane destroyed breakwater and vegetation.

In the spring of 1995 the sandy area behind the breakwater was again replanted with *Spartina patens* and *Spartina bakeri*. These plants became established and grew well throughout the 1995 growing season. The area was pounded by a hurricane in September 1995. While the plants sustained some damage, many survived. This event, however, destroyed the wire wrapped straw bales.

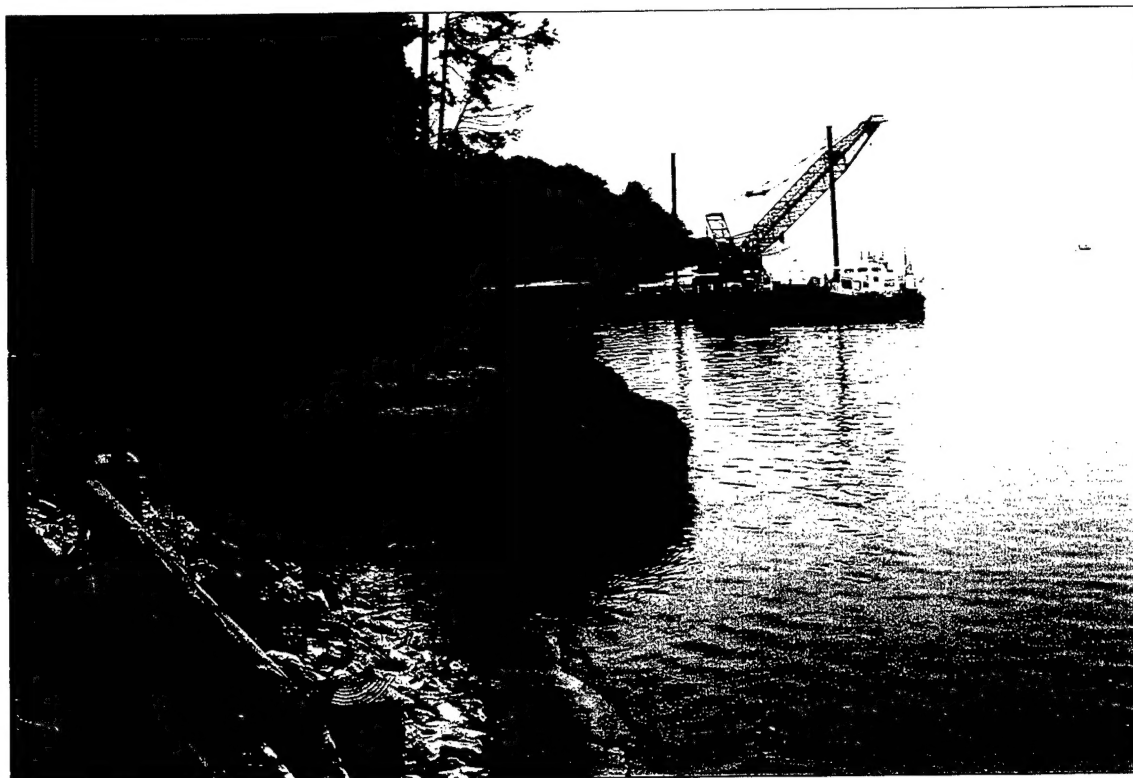
Large round hay bales placed as a breakwater.

Eighty bales weighing 1000 to 1200 lbs each were placed in a row on the shoreline at an elevation of approximately 187 feet in December 1994. This created a protected area

about 400 feet in length. Both ends of the row were tied in to the hillside to prevent waves from flowing behind them. With the bales placed at 187 feet we expected that about 40% of the lower end of the bales would be in the water at full pool. We thought that the bales would trap sand as the water rose and would become too heavy to float even in high water.

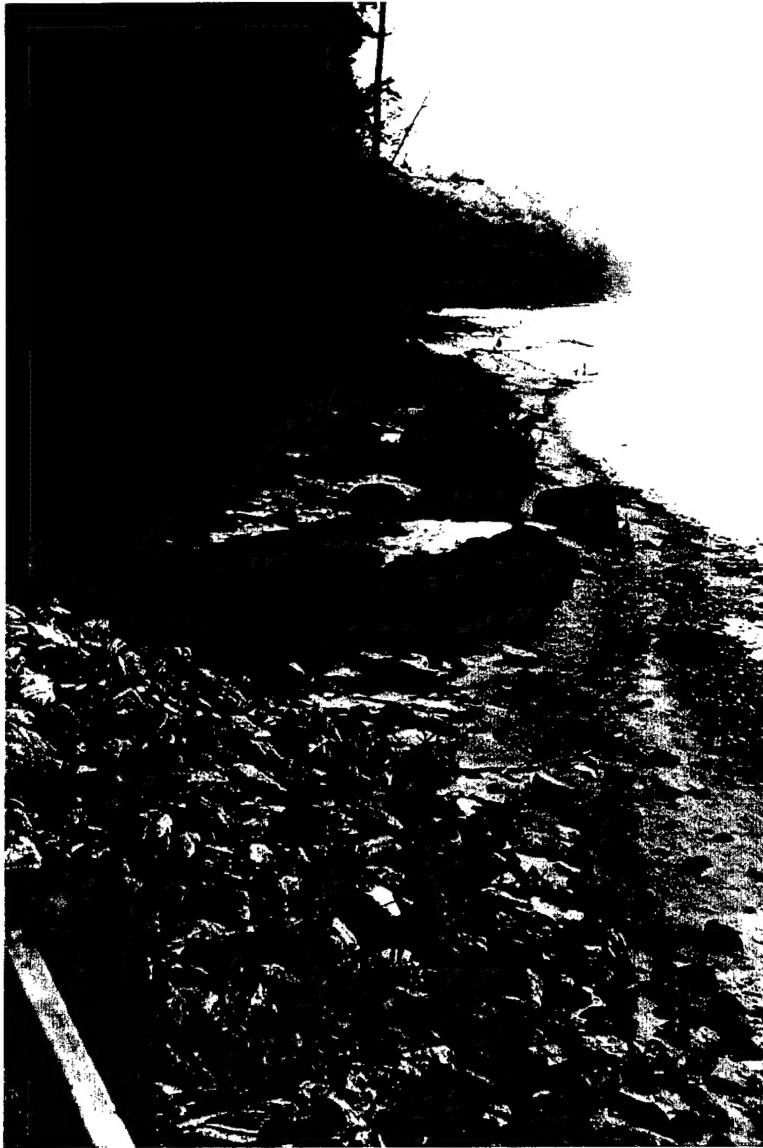
Hay bale breakwater was destroyed by flooding.

The January 1995 high water episode described above was also responsible for destroying this installation. The lake level rose above the tops of the bales and caused them to float out into the lake. Since this was thought to be an isolated incident the Corps of Engineers personnel salvaged enough of the bales to create a new breakwater about 200 feet in length, however, within a few months the waves destroyed this also.

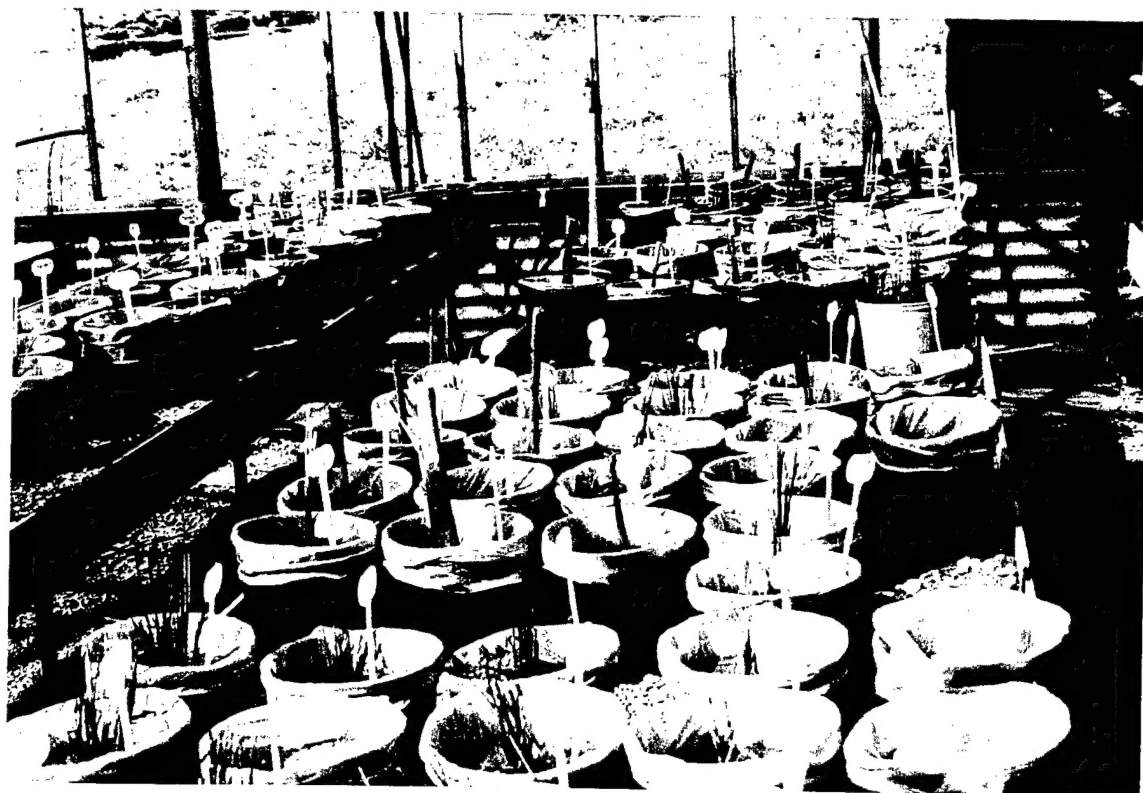
Newly planted wetland plants.

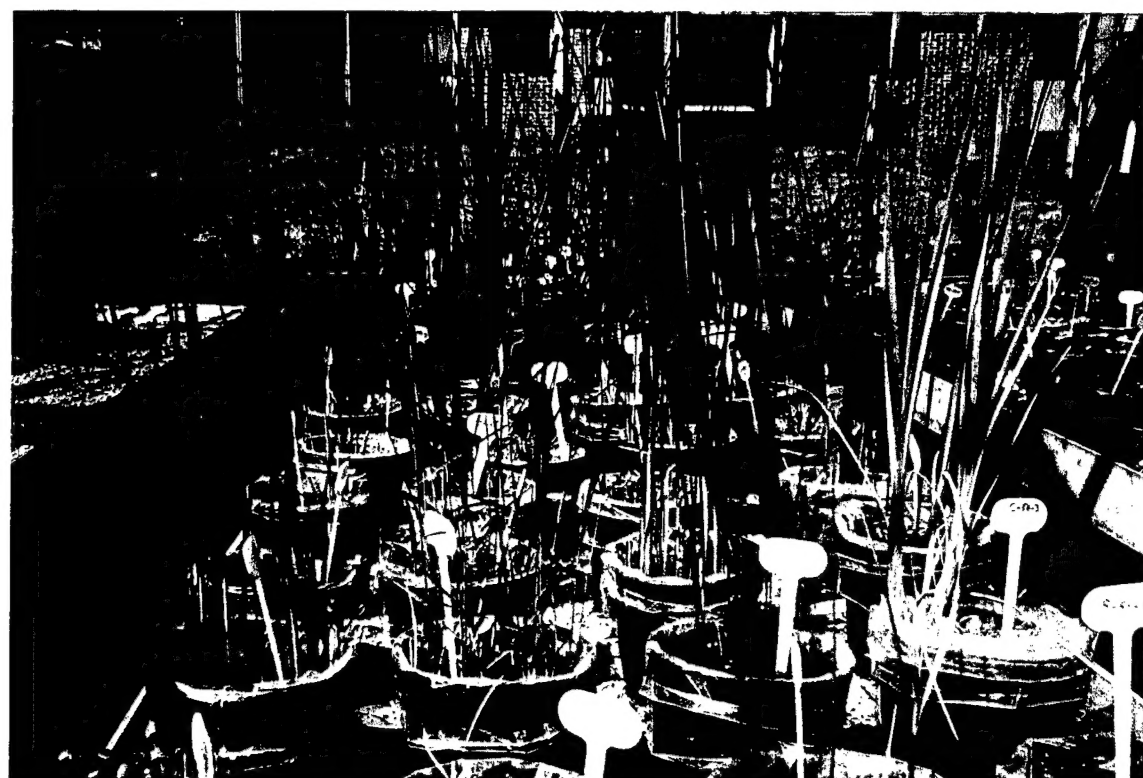
Wetland plants ready for harvest.
